A HISTORY OF FULL-SCALE TESTING OF AIRCRAFT STRUCTURES AT THE NATIONAL AERONAUTICAL ESTABLISHMENT

R.L. Hewitt

National Aeronautical Establishment

AERONAUTICAL NOTE
NAE-AN-24
NRC NO. 24089

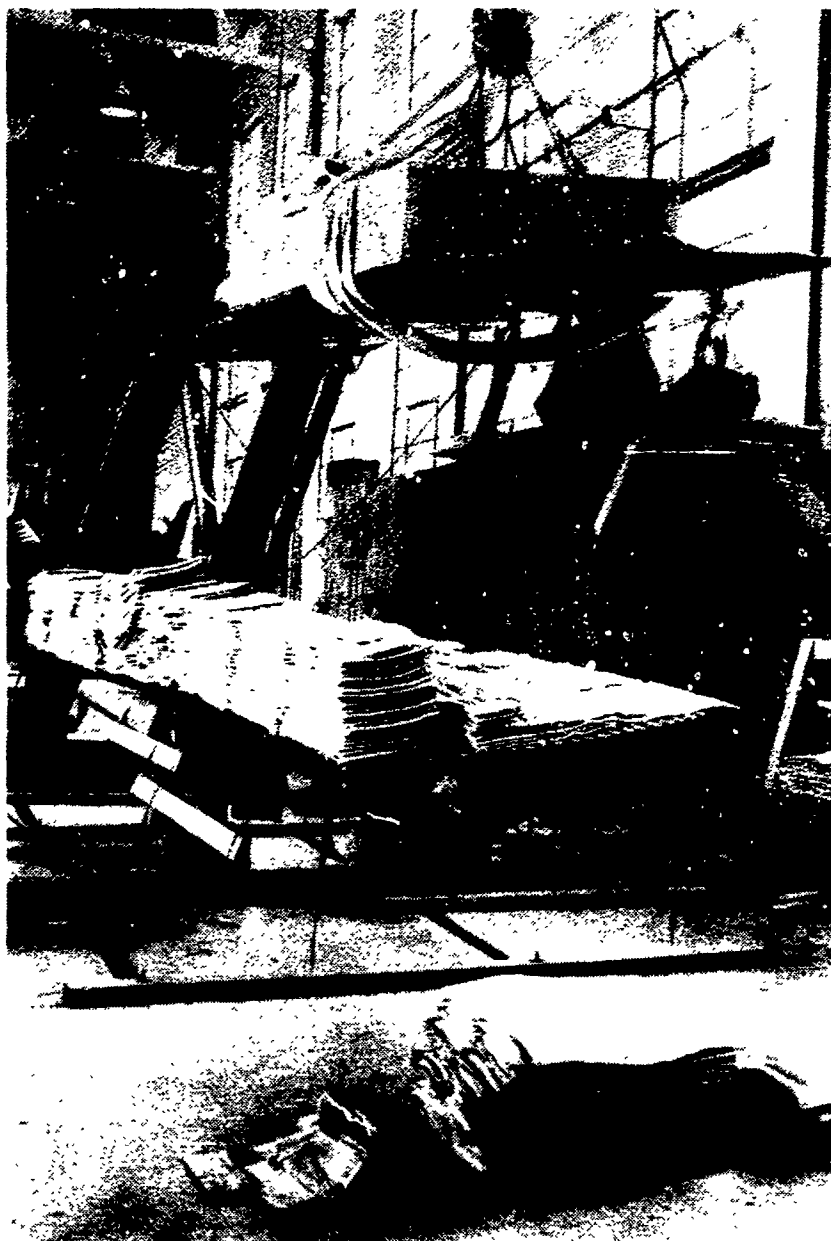
FIG. 2: PROOF LOAD TEST ON AN 800-HOUR TIGER MOTH WING

They were rigged in the inverted position in a test stand as shown in Figures 1 and 2 with root end fittings provided to apply the correct type of reaction. Slot and balancing loads were provided by loading platforms and a system of wooden levers (early whiffletrees) while a box on the lower wing was located to provide strut reactions. Short slats spanned the rib intervals and transmitted shot bag loads directly to the rib trusses. A frame supported by hydraulic jacks provided an abutment for the structure to rest on during loading operations, while a sling was loosely looped around the lower wing as a precautionary measure. Deflections along the leading and trailing edges were measured by a mechanical "strain gauge" reading to 0.001 ft. All wings were loaded to 120% of ultimate load without collapse and it was concluded that there was no evidence of deterioration with age or failure in the glued joints.

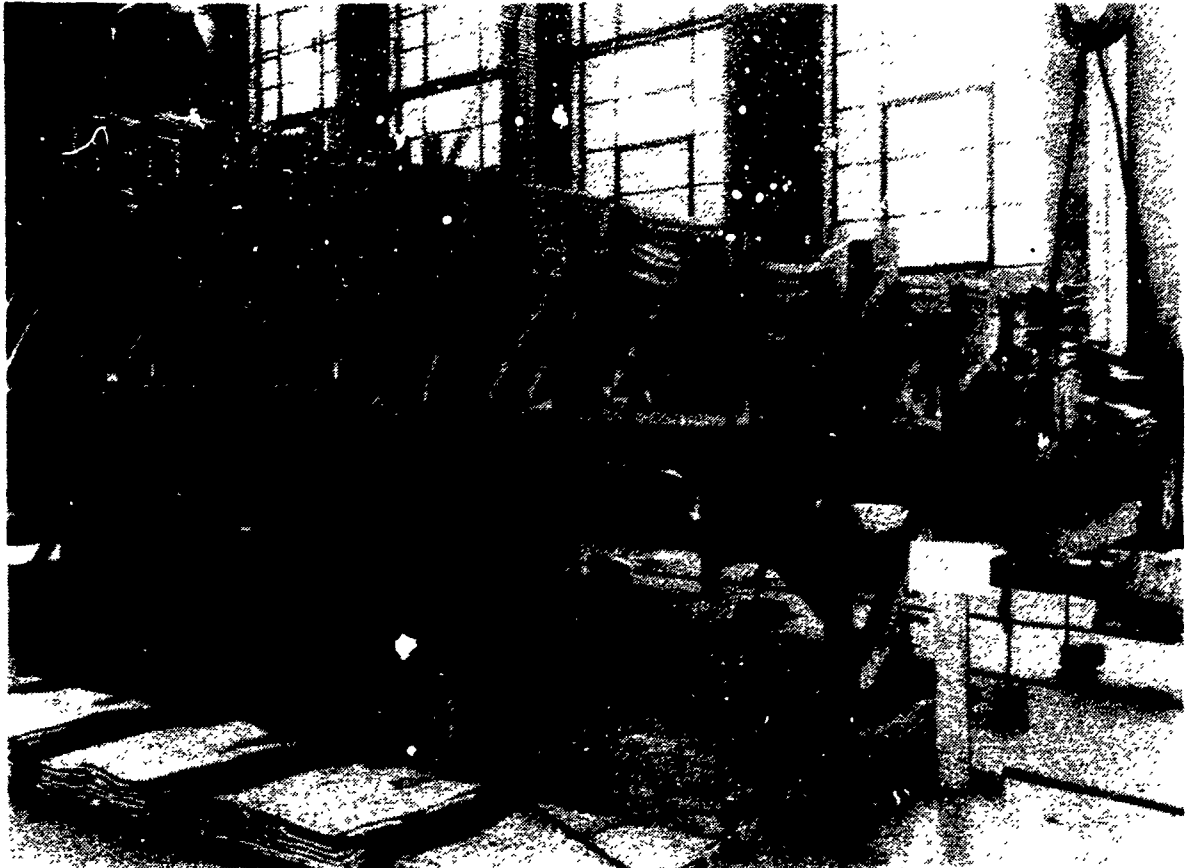
FIG. 3: HARVARD II MAINPLANE AT 90% SPECIFIED ULTIMATE LOAD

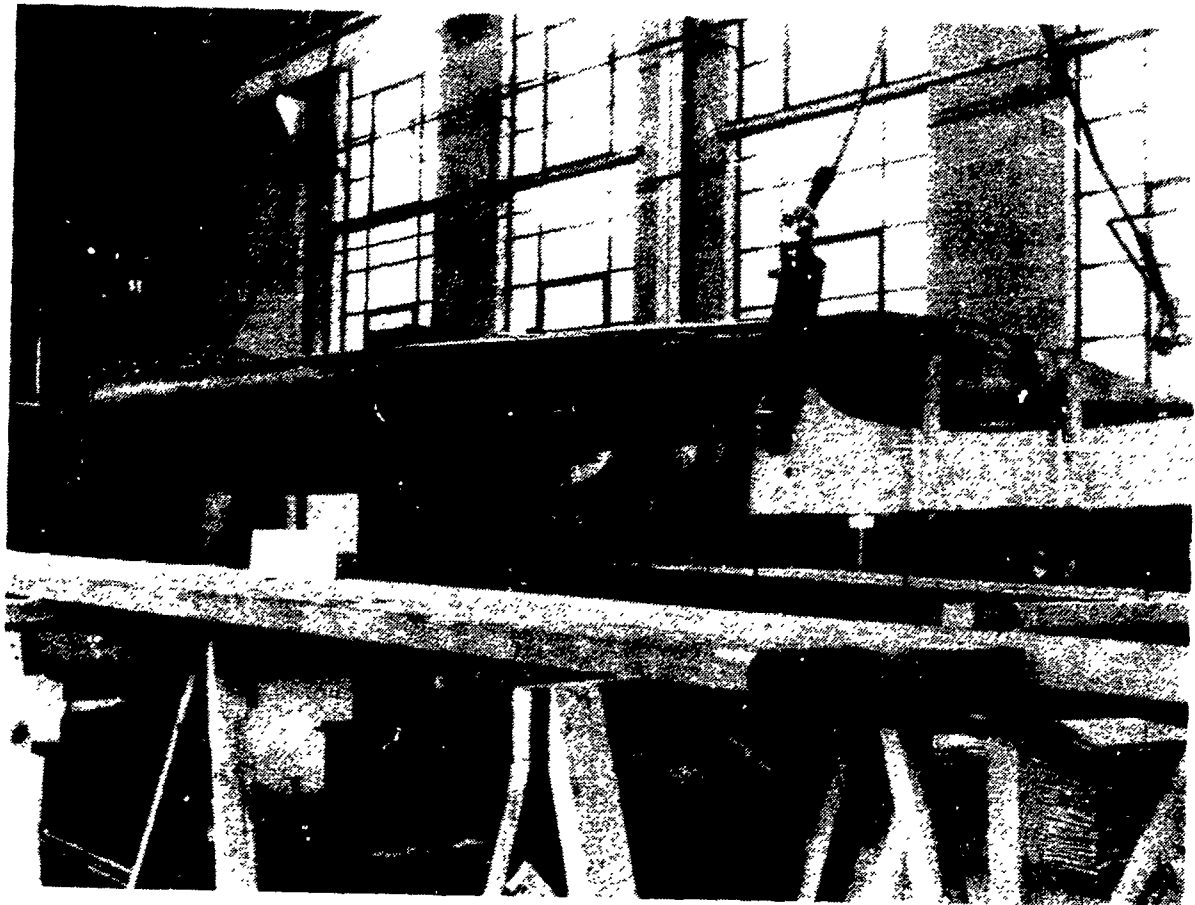
FIG. 5: MOULDED WOOD HURRICANE WING PANEL

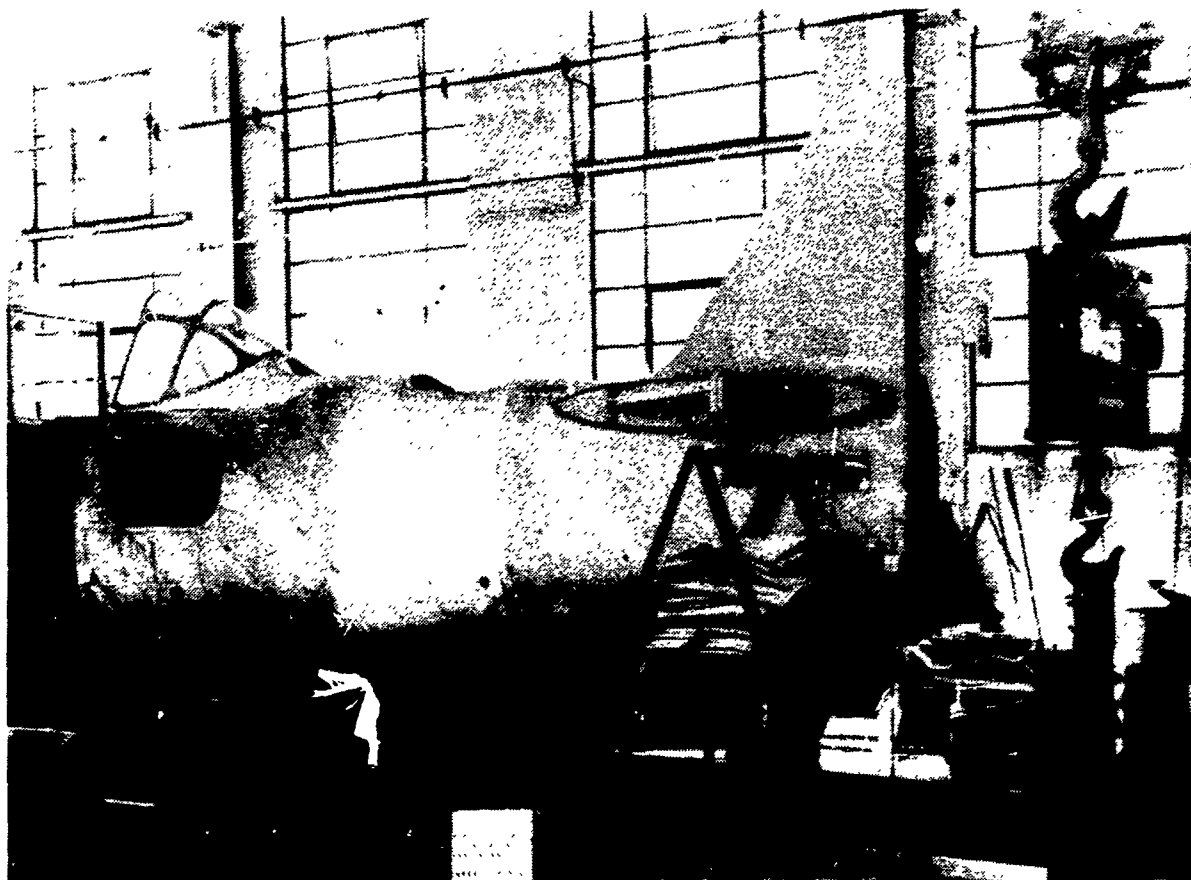
FIG. 6: MOULDED PLYWOOD HARVARD FUSELAGE UNDER ULTIMATE DESIGN LOAD
FOR A SPECIAL TAILWHEEL CONDITION AFTER REPAIR

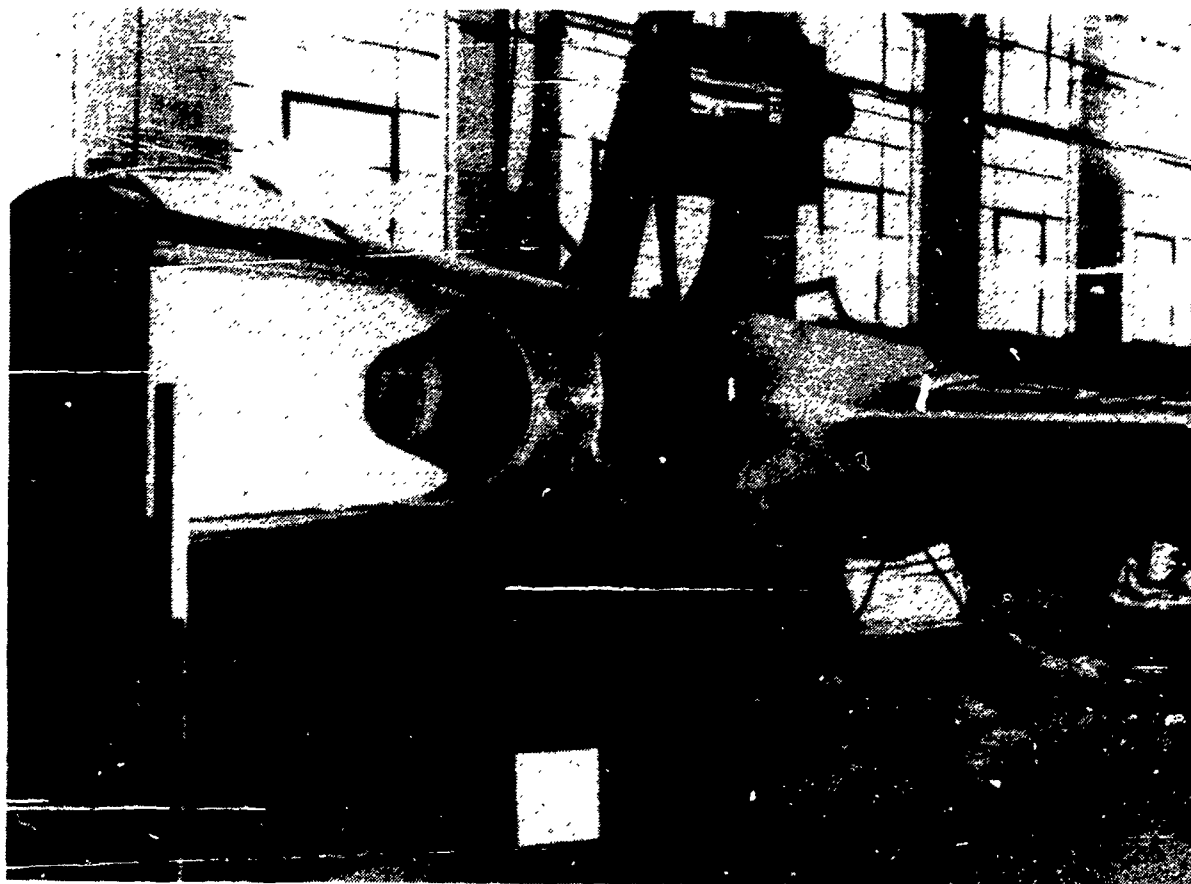
FIG. 7: HORIZONTALLY MOUNTED TEST OF MOULDED PLYWOOD HARVARD FUSELAGE

positions (Figure 7) for various loading conditions and loads applied by means of lead weights and lead shot bags for down loads and by a hand hoist, scale balance and a steel beam for up loads. Deflections were measured with a surveyors level and "strain gauges". All the design loads were successfully carried except for a "special tailwheel condition B" which resulted in a failure of the lower skin fibres at 100% design load, Figure 8, due to a stress concentration at the sharp corner of the flare cut-out and lack of continuity of the short stiffeners which carried the flare tube brackets. After repair and modification the design load was successfully carried.

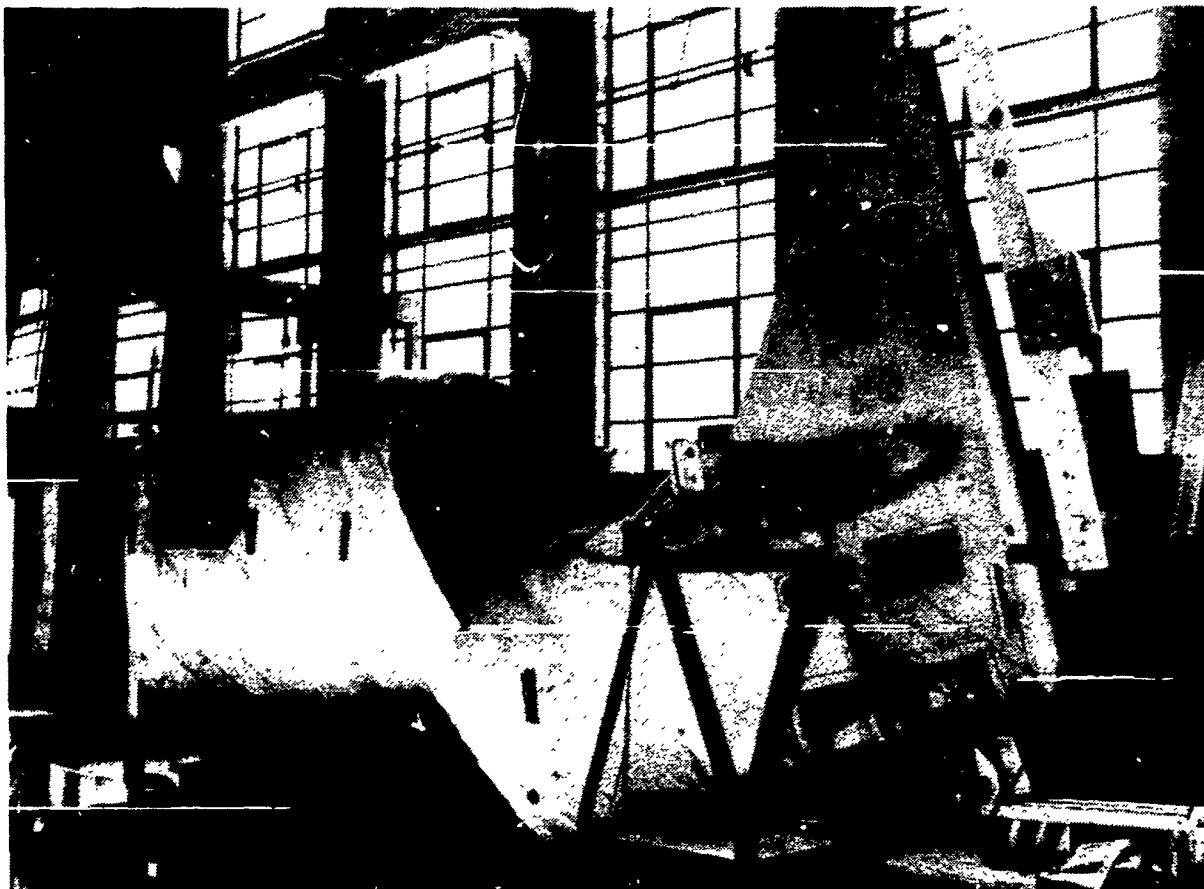
FIG. 8: FAILURE OF MOULDED PLYWOOD HARVARD FUSELAGE UNDER
A SPECIAL TAILWHEEL CONDITION

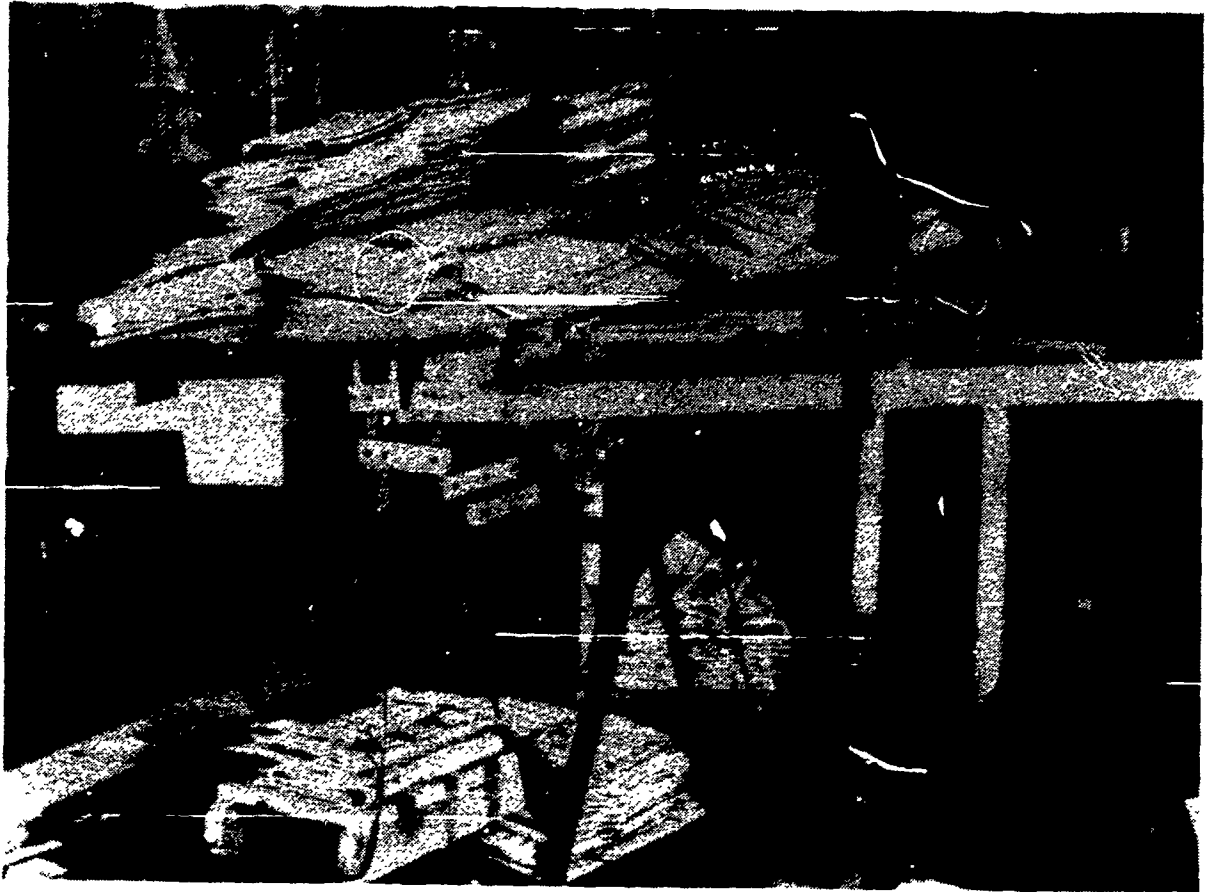
FIG. 9: STATIC TEST OF MOULDED PLYWOOD HARVARD STABILIZER

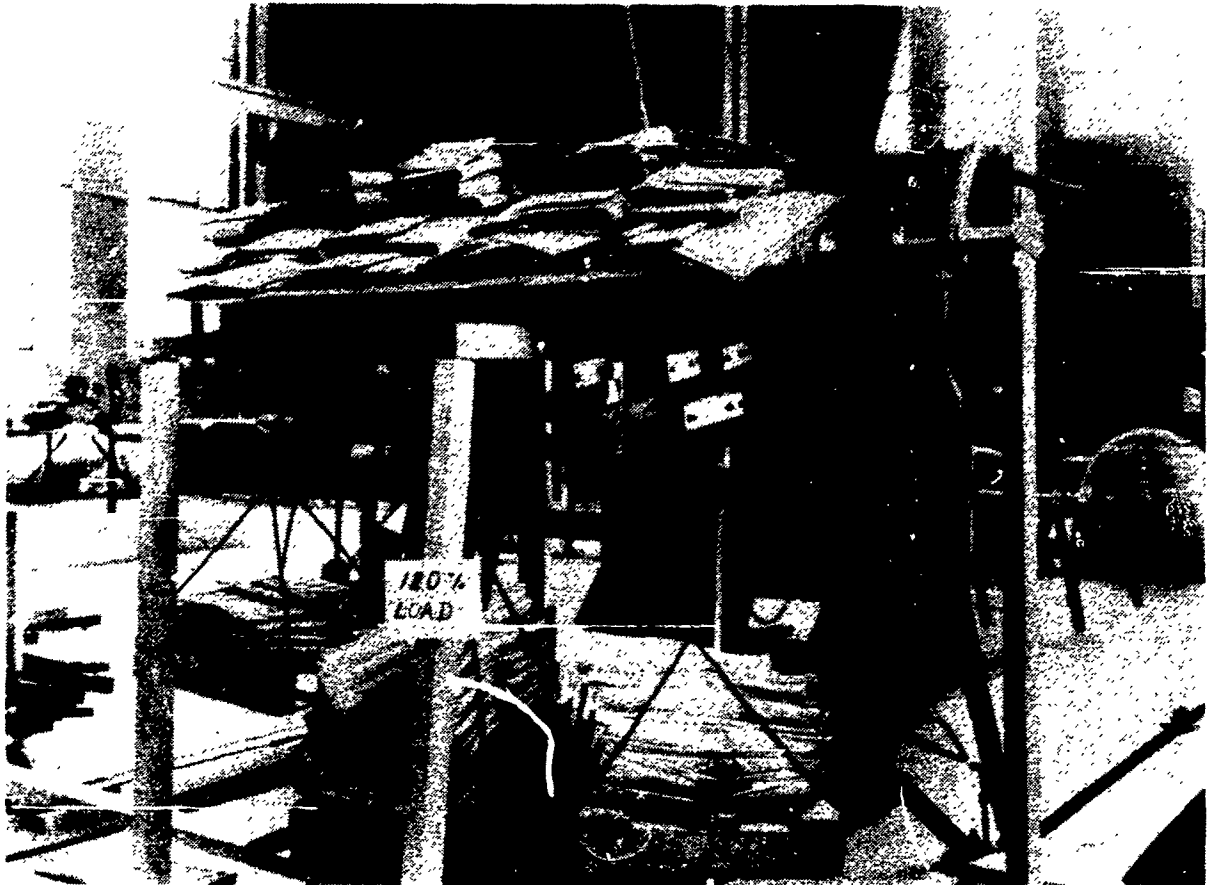
FIG. 10: STATIC TEST OF MOULDED PLYWOOD HARVARD ELEVATOR

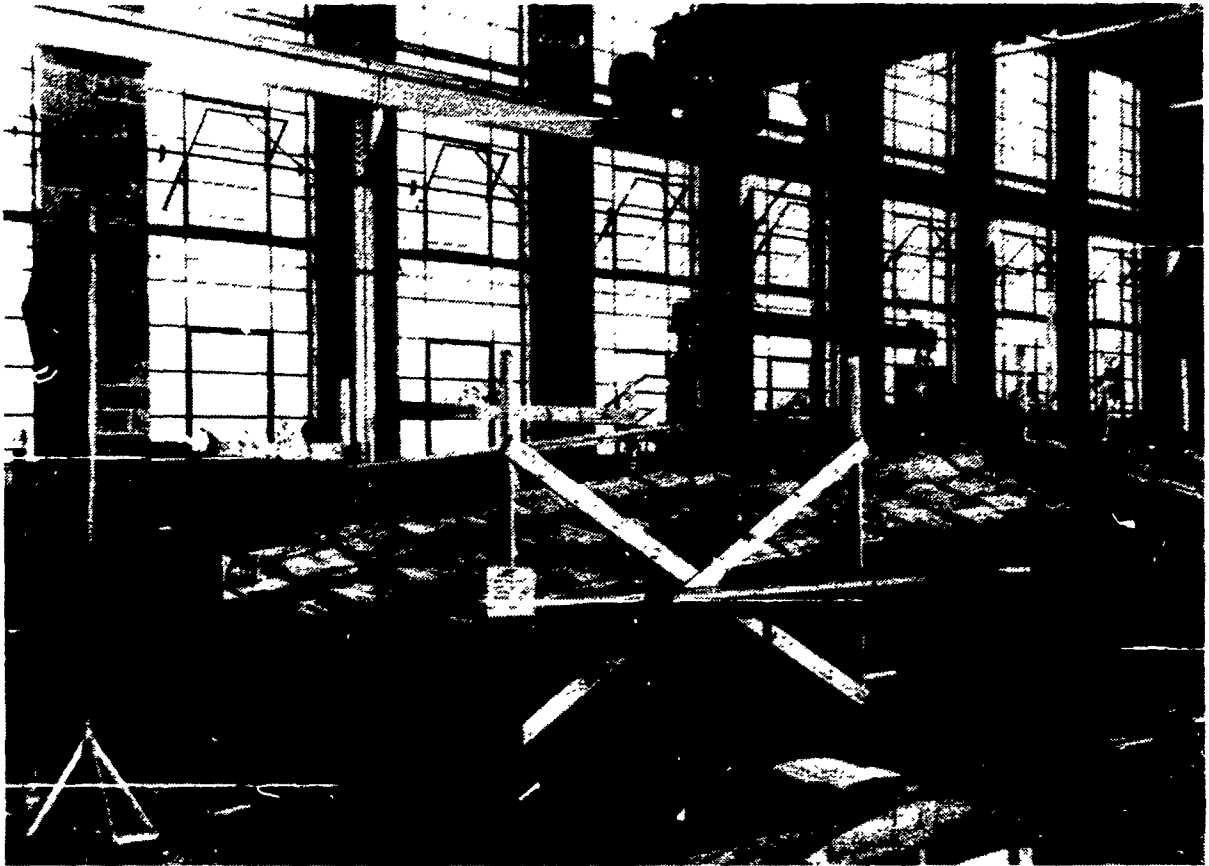
**FIG. 12: ANSON MAINPLANE UNDER LOAD SHOWING WHIFFLETREE
FOR APPLYING ENGINE AND UNDERCARRIAGE LOADS**

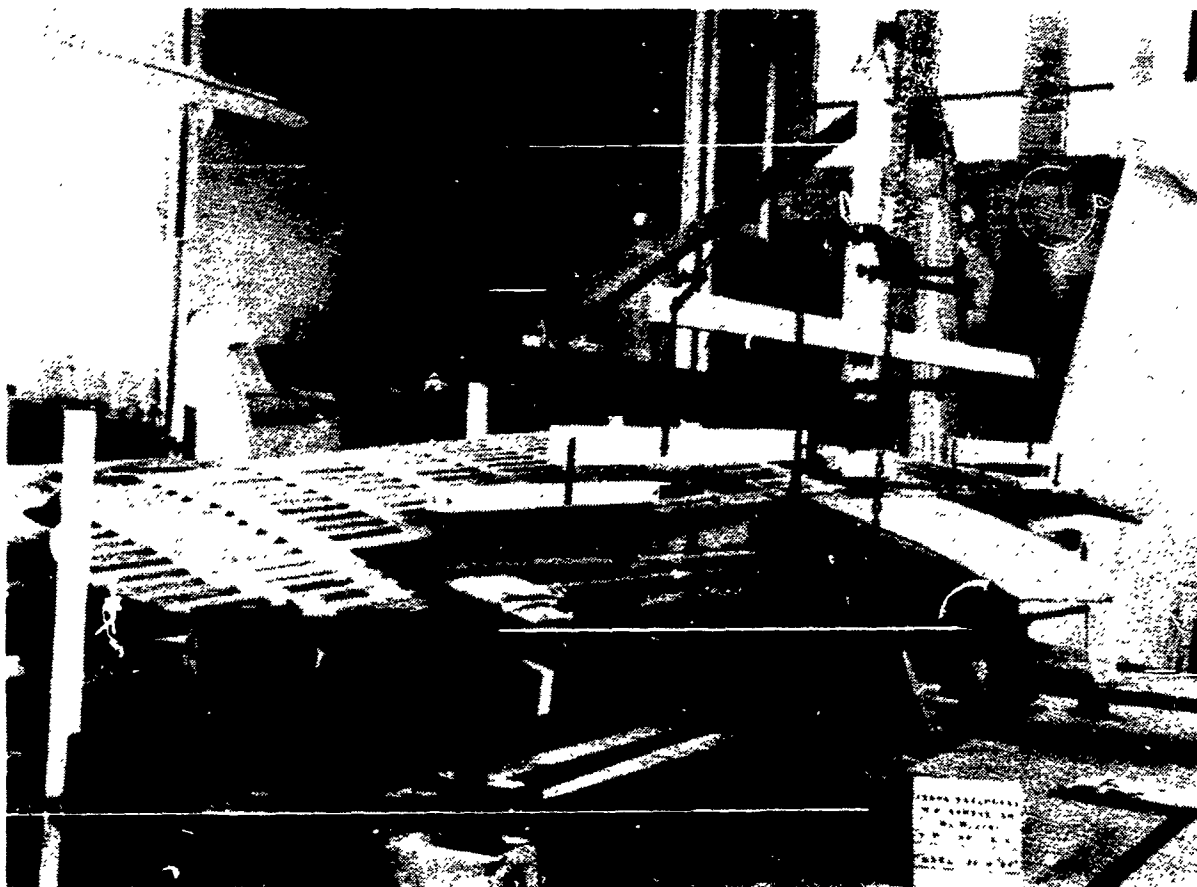
FIG. 13: TEST SET-UP FOR ANSON TAILPLANE

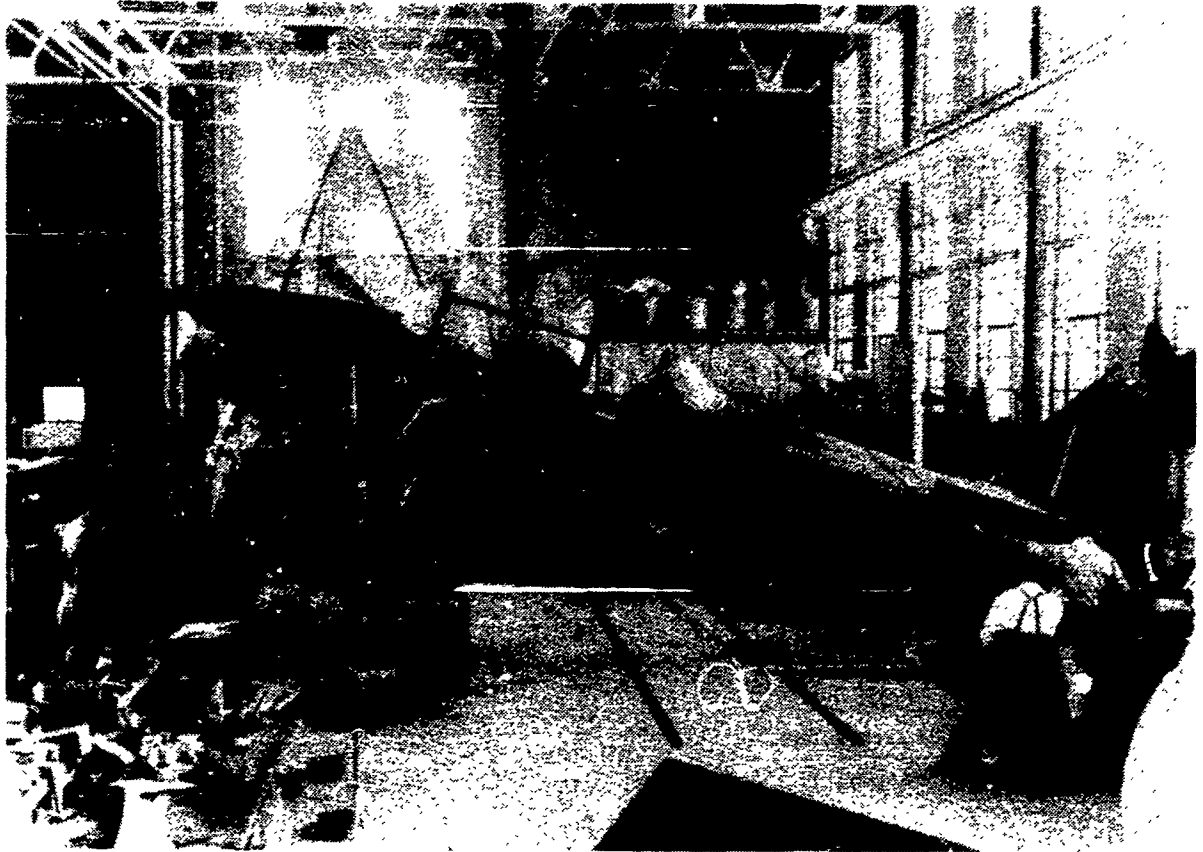
FIG. 14: DROP TEST OF A CORNELL AIRCRAFT

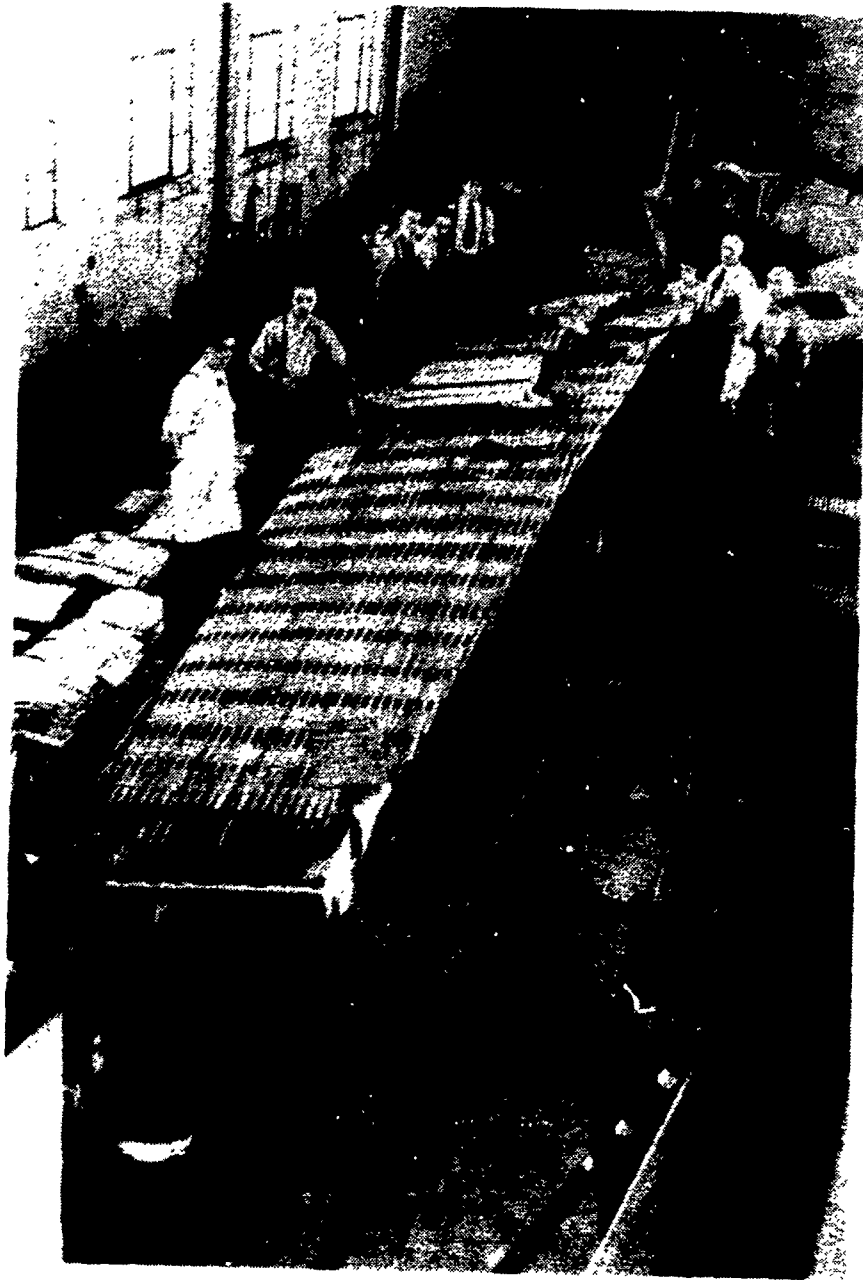
FIG. 15: TEST SET-UP FOR CORNELL WING

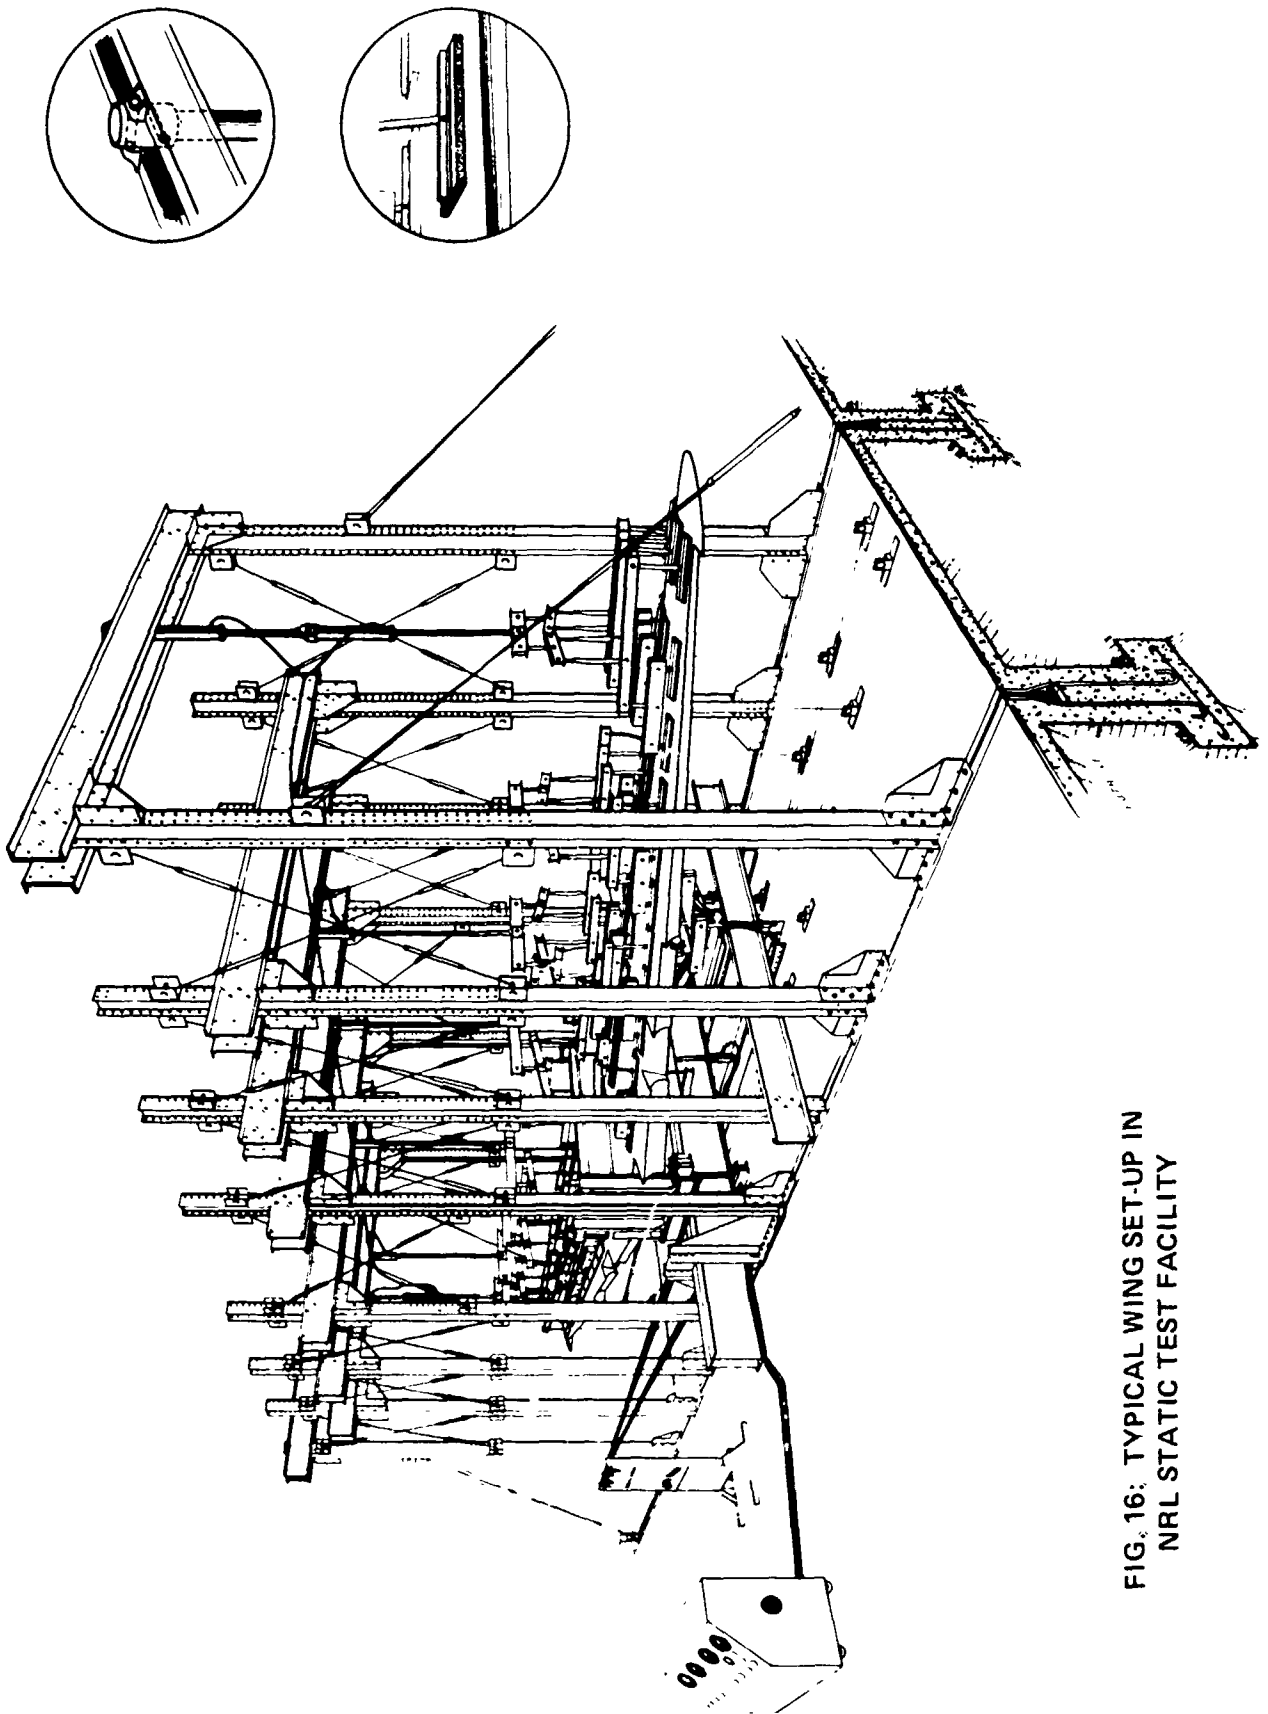
FIG. 16: TYPICAL WING SET-UP IN
NRL STATIC TEST FACILITY

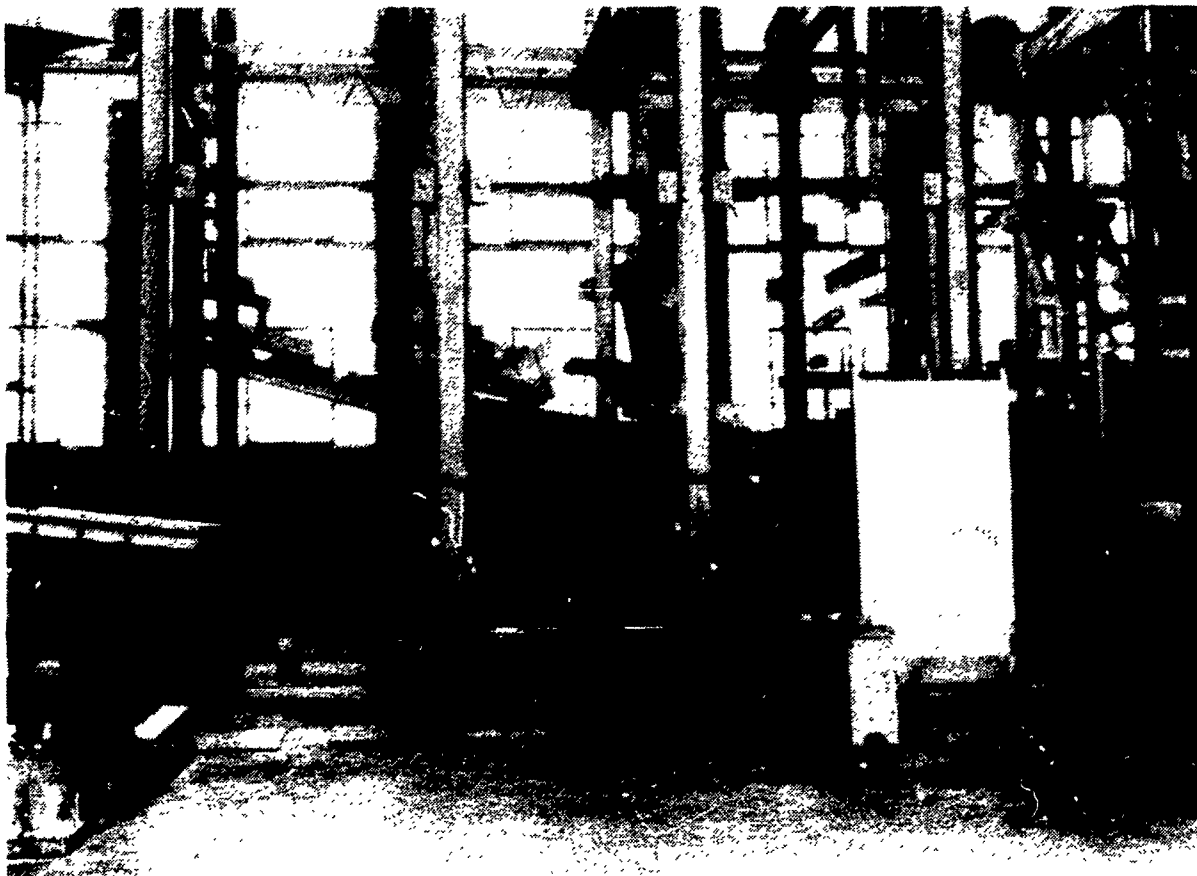
FIG. 17: FAILURE OF A USED MOSQUITO WING AT 95% ULTIMATE FACTORED LOAD

Failure of wings I and II occurred while holding 95% ultimate factored load as shown in Figure 17. Wing III failed while holding 85% ultimate factored load. Lacking specific information on the length of service and storage of the wings tested, no conclusion concerning deterioration could be drawn, but there was no evidence to suggest that the failures below ultimate factored load could be attributed to deterioration in service or storage.

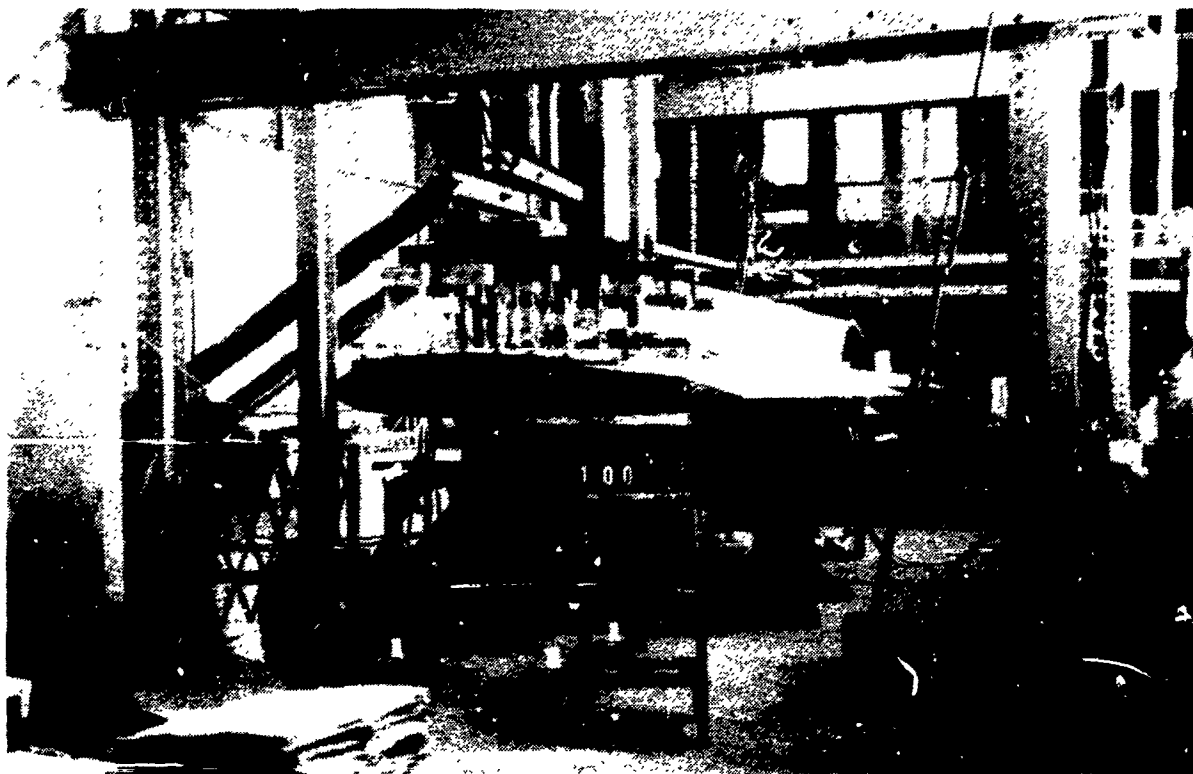
FIG. 18: TEST OF C-102 DERWENT FIN

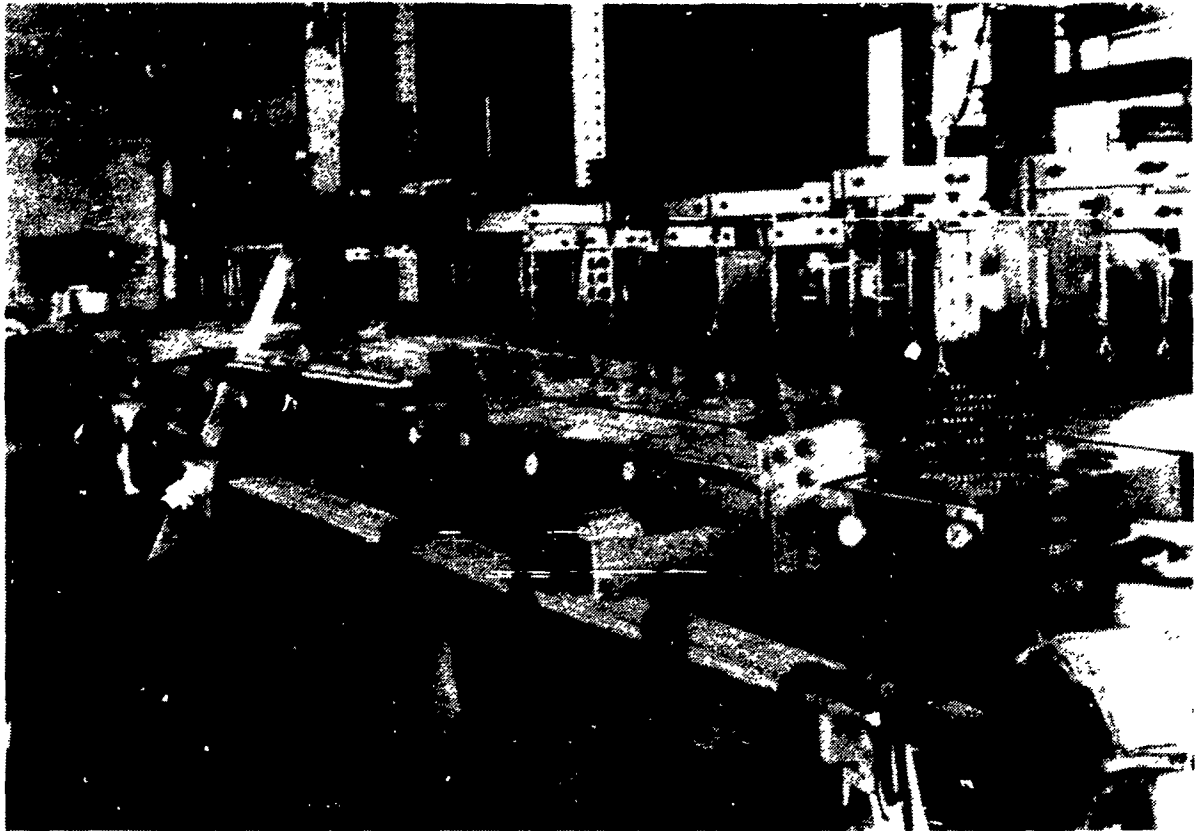
FIG. 19: TEST OF C-102 DERWENT TAILPLANE

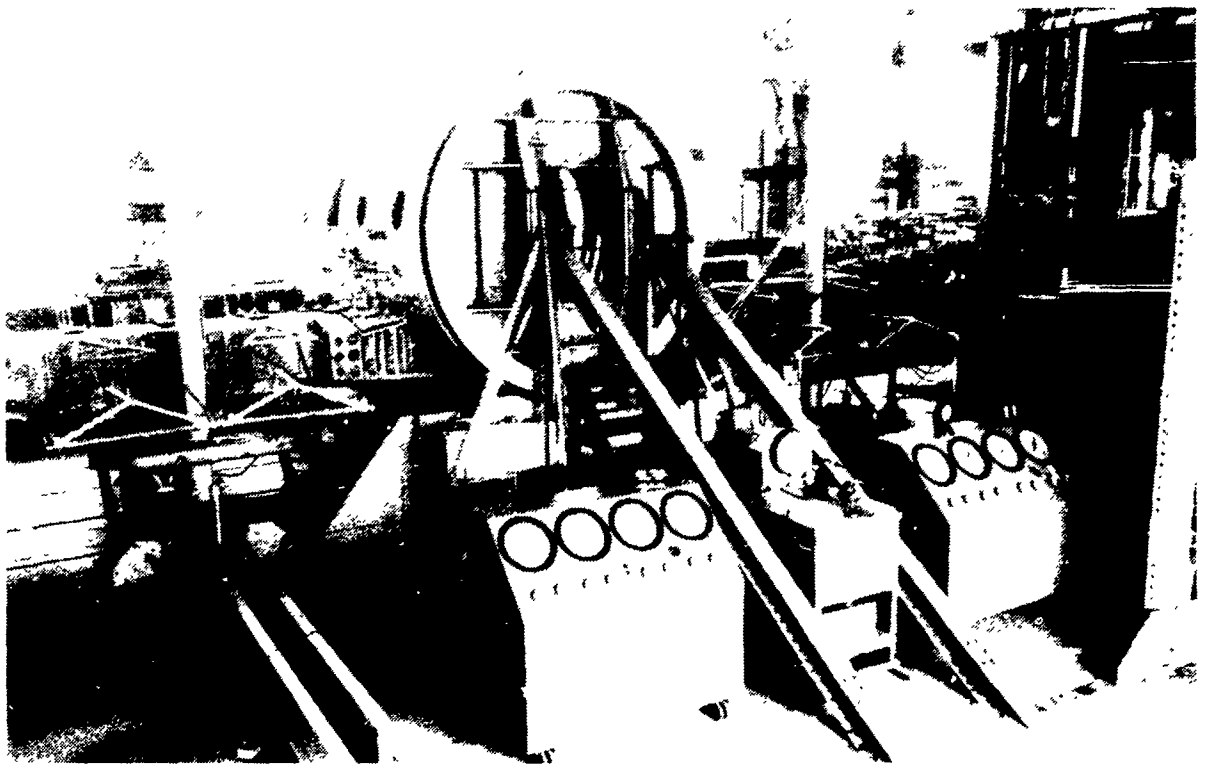
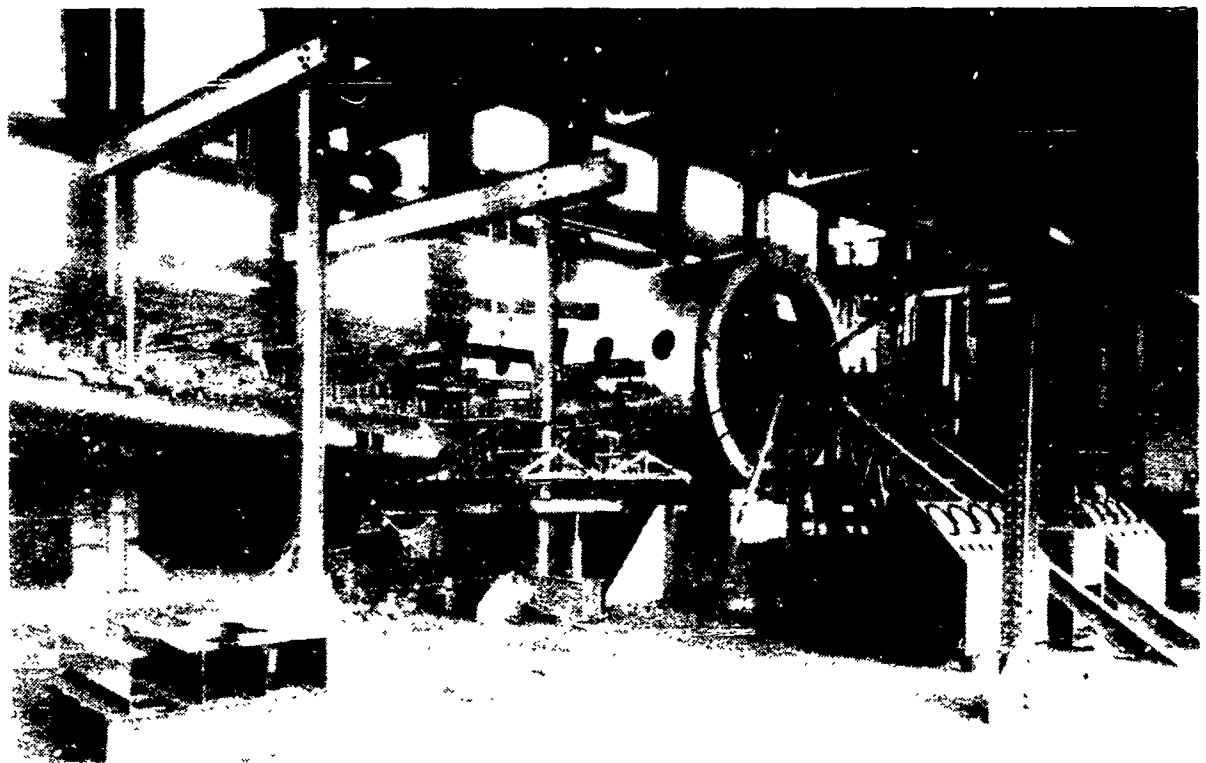
FIG. 20: TEST SET-UP FOR C-102 DERWENT MAINPLANE AND CENTRE FUSELAGE

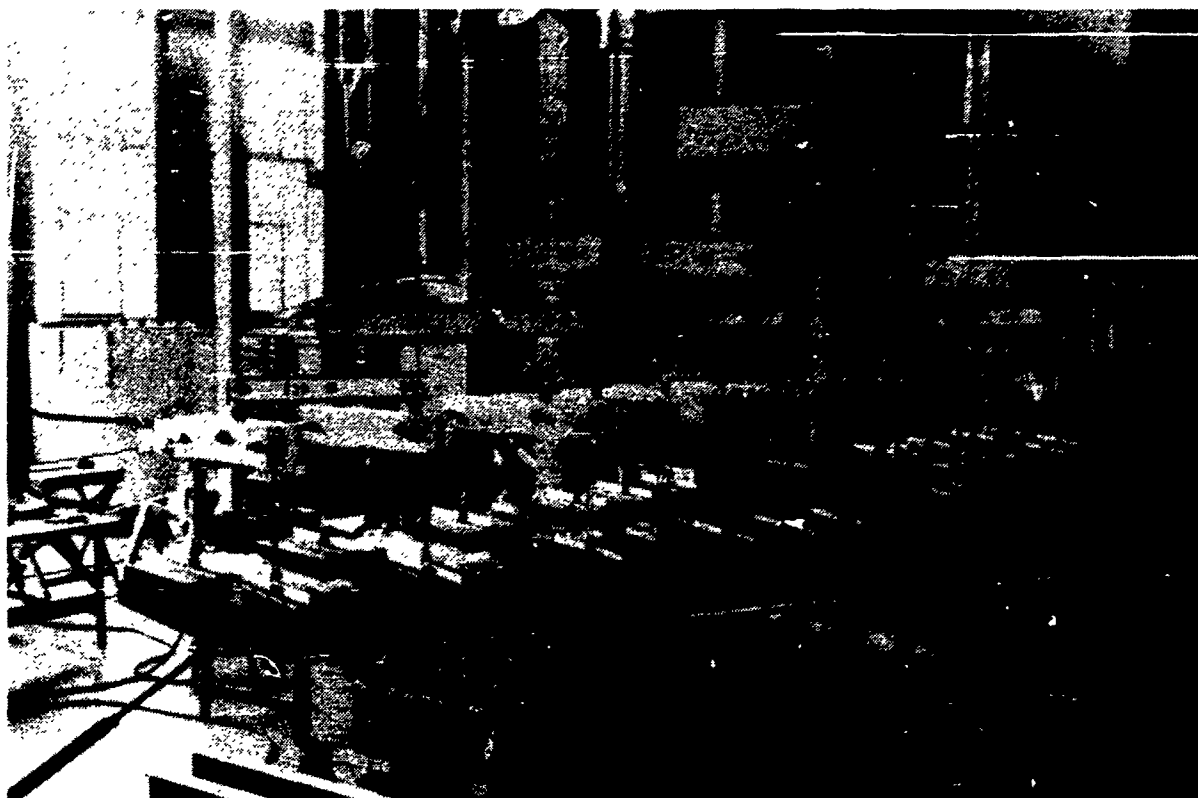
FIG. 22: TEST OF C-100 TAILPLANE

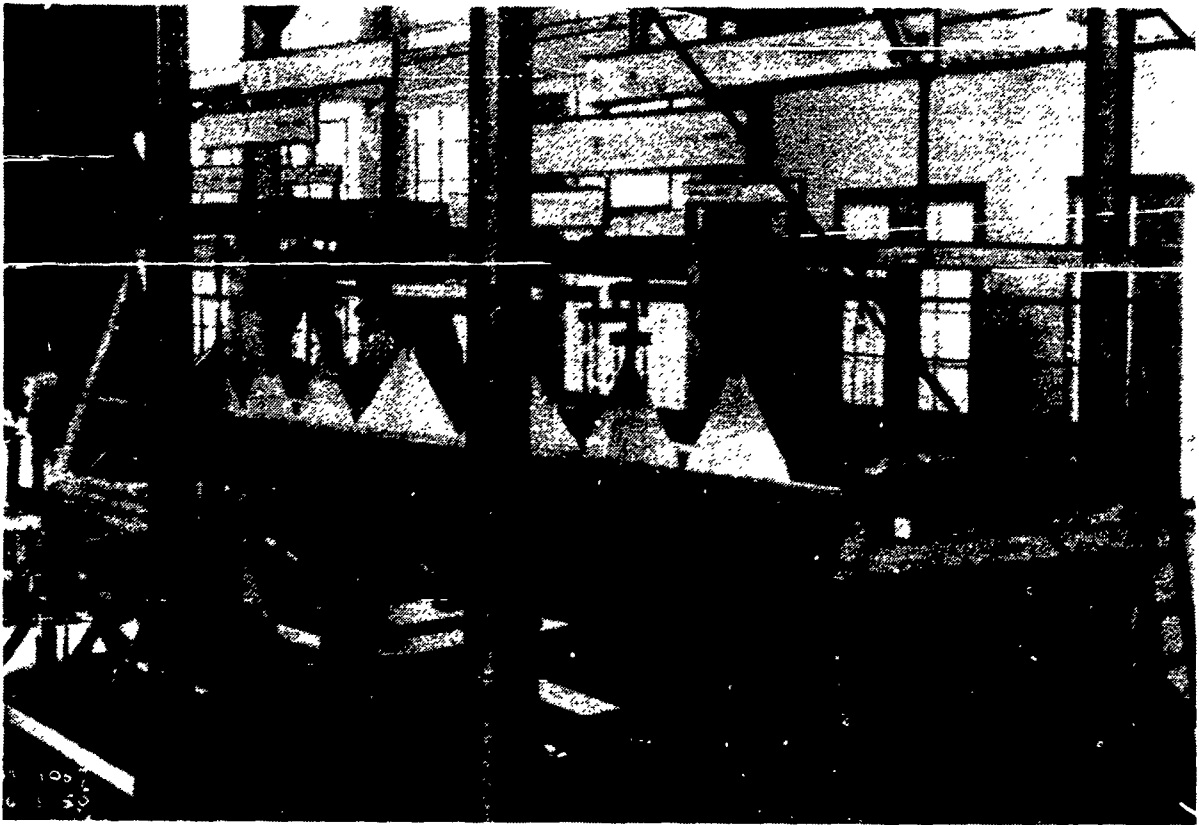
FIG. 23: TEST SET-UP FOR C-100 OUTER WING SHOWING RIVETED ATTACHMENTS
TO LEADING EDGE
